STRUCTURAL CONDITION ASSESSMENT

ALLEN JAY ROCK GYM
1201 FAIRFIELD ROAD
HIGH POINT, NC

Prepared for: Guilford County Schools
617 West Market Street
Greensboro, NC

January 04, 2012

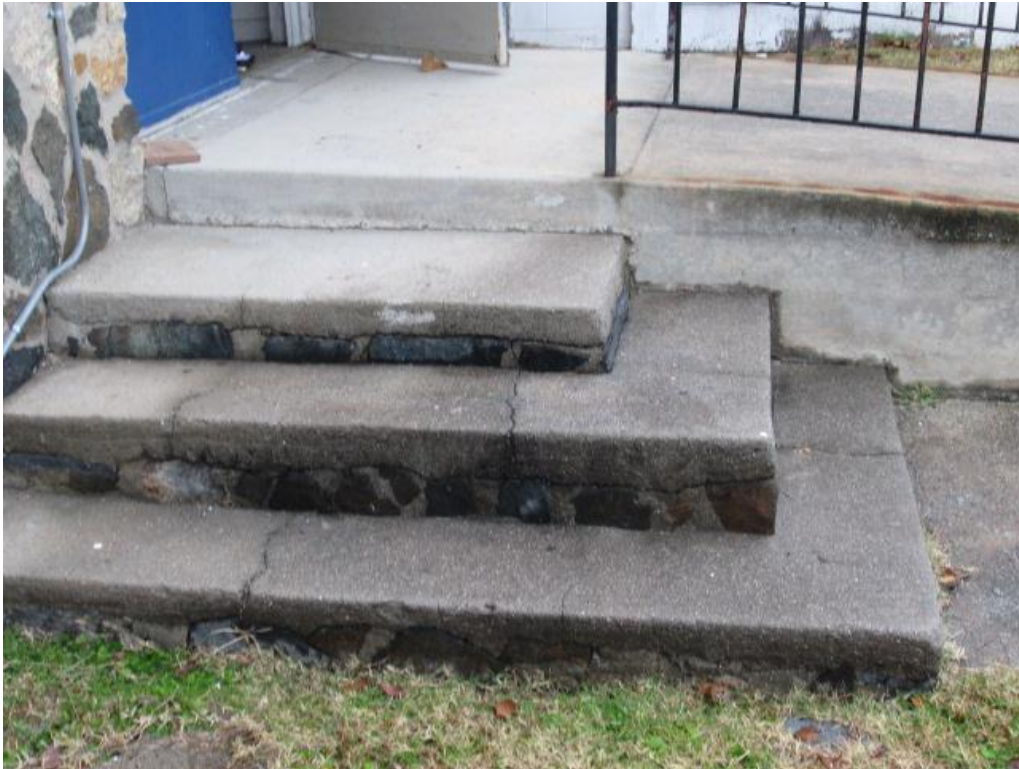
Stone masonry steps with a concrete topping are located on both sides of the concrete entry landing (Photos 8-9). The concrete topping appears weathered with cracks up to 1/8 inch wide. The cracks should be repaired to minimize the potential for pedestrian tripping and water infiltration damage.

Photo 7: Left side concrete stair (facing main entry)

- 1) Repair cracks in concrete topping at steps at the south building entrance.
- 2) Repair coatings at the west elevation stair.

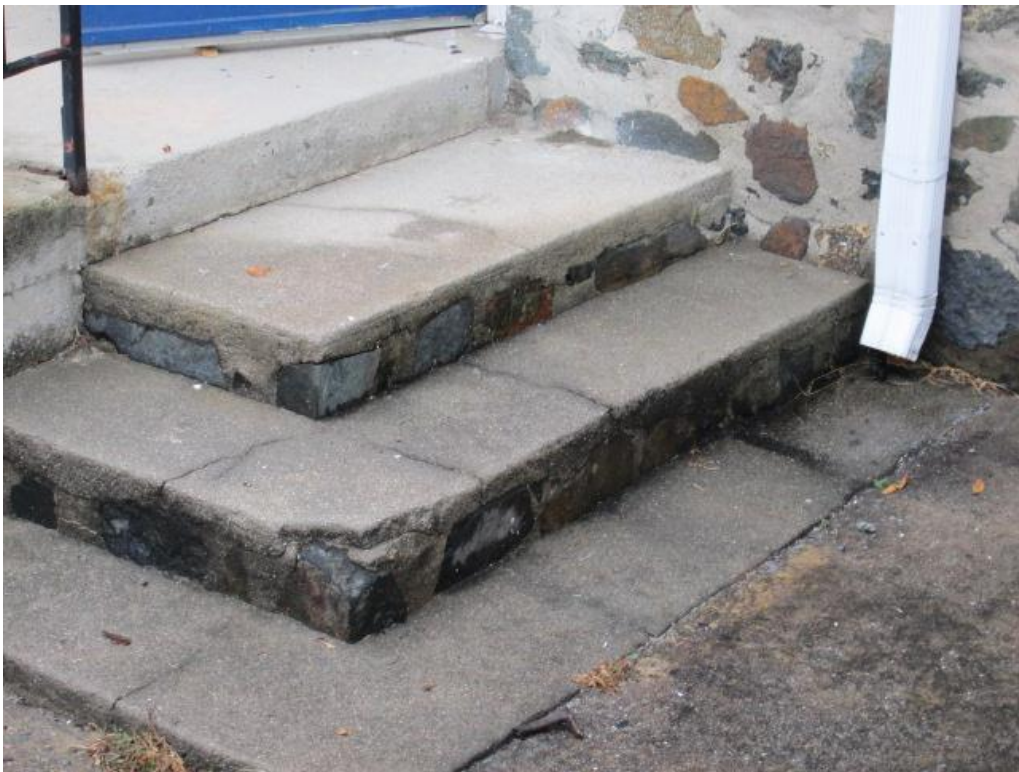
Photo 8: Right side concrete stair (facing main entry)

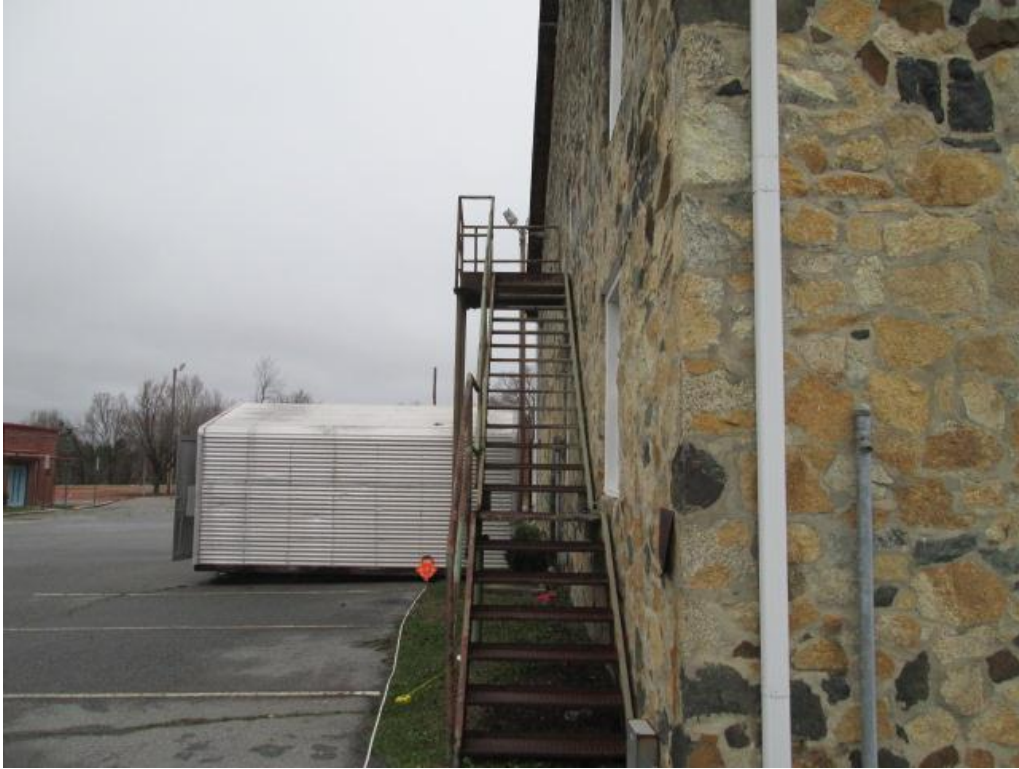
A steel stair is located at the west elevation of the building leading to a second story entrance (Photos 11-12). The paint coating has significantly deteriorated with bare metal exposed at the majority of the stair system. Corrosion has begun to set in but no significant section loss was observed at the time of observation. The coatings should be repaired to prevent steel degradation.

Photo 11: Exterior steel stair at west elevation

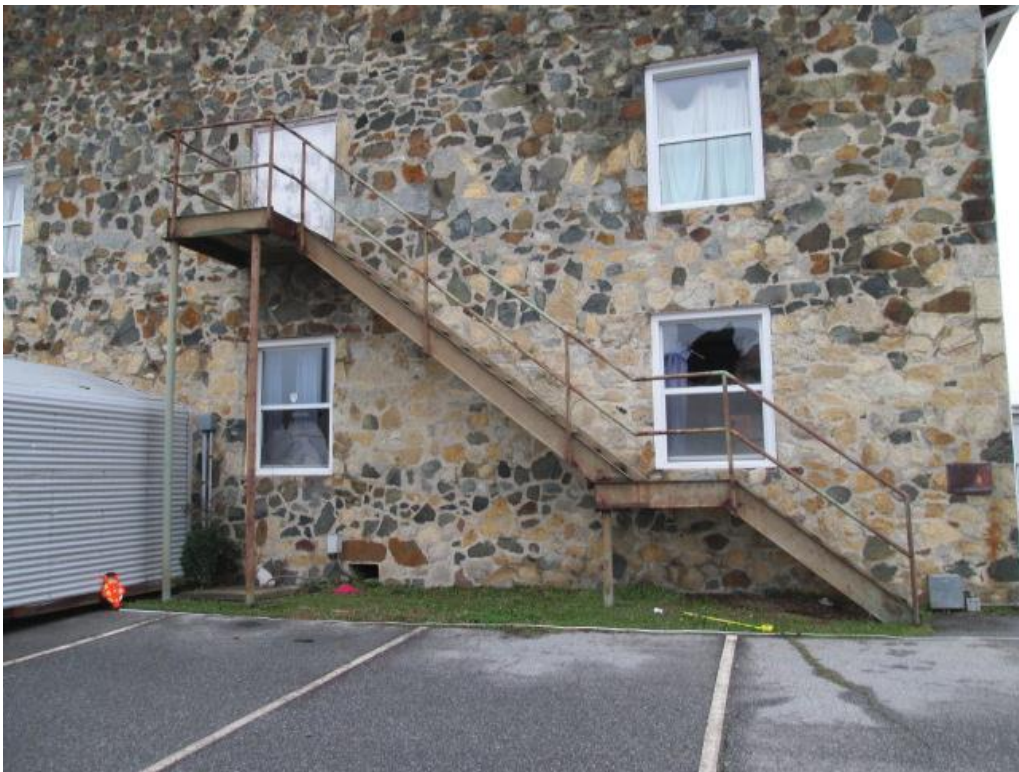
Photo 12: Side view of exterior steel stair

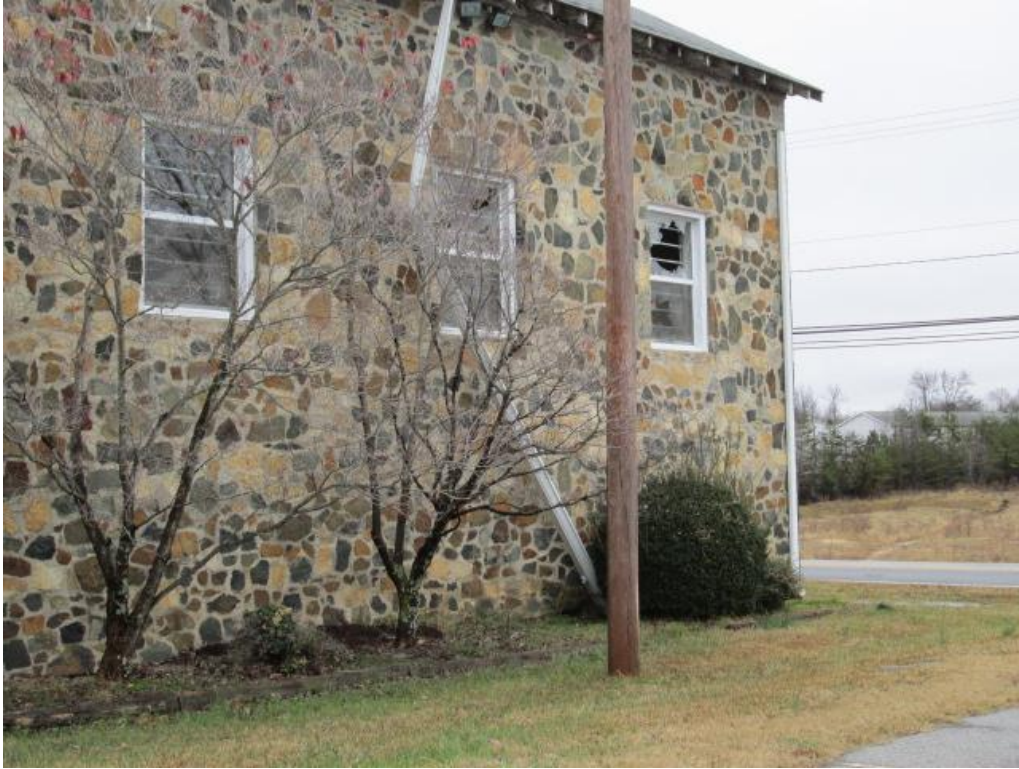
The aluminum gutters are damaged at the south and north elevations of the building. At the south elevation a section of the aluminum gutter has come unattached from the roof and is hanging towards the ground (Photo 13). At the north elevation the aluminum gutter is bowed and warped (Photo 14). The damaged aluminum gutters should be replaced.

Photo 13: Damaged/down gutter south elevation (View from East Fairfield Road)

- 1) Replace/repair existing roofing.
- 2) Demolish rear storage building or repair roofing, roof framing and ceiling.
- 3) Remove vegetation growing on the west wall.
- 4) Replace all damaged and/or non-operable windows.
- 5) Consider additional security lighting to deter vandalism.
- 6) Repair/replace damaged aluminum gutters.

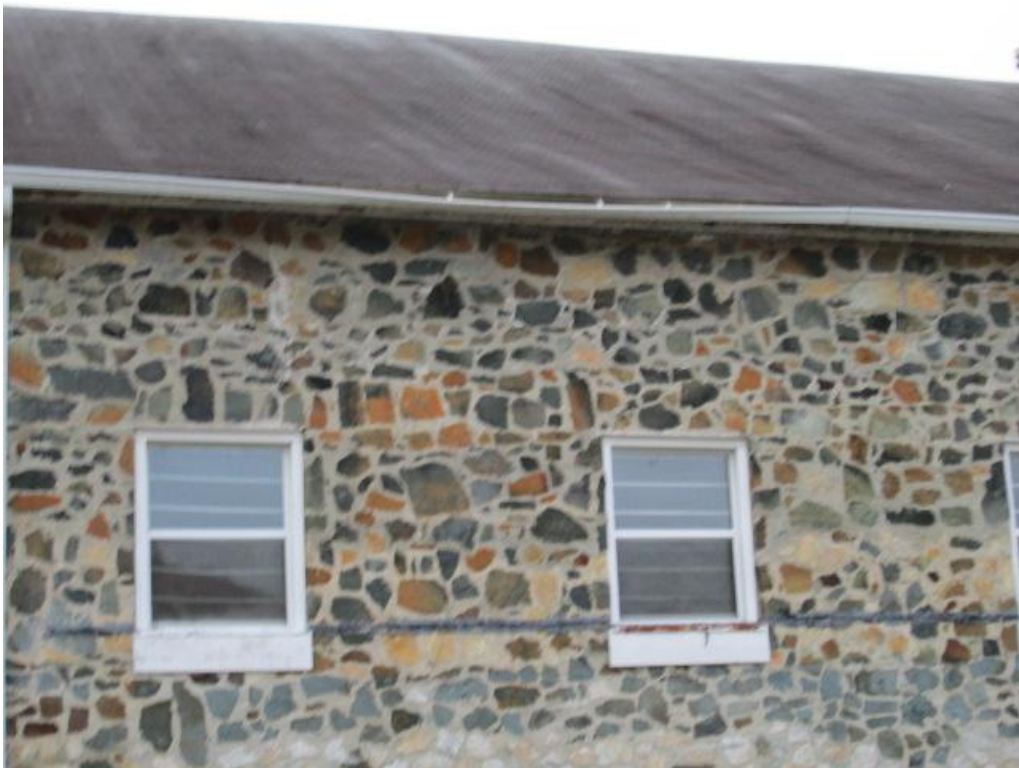
Photo 14: Damaged gutter north elevation (View from Pegram Avenue)

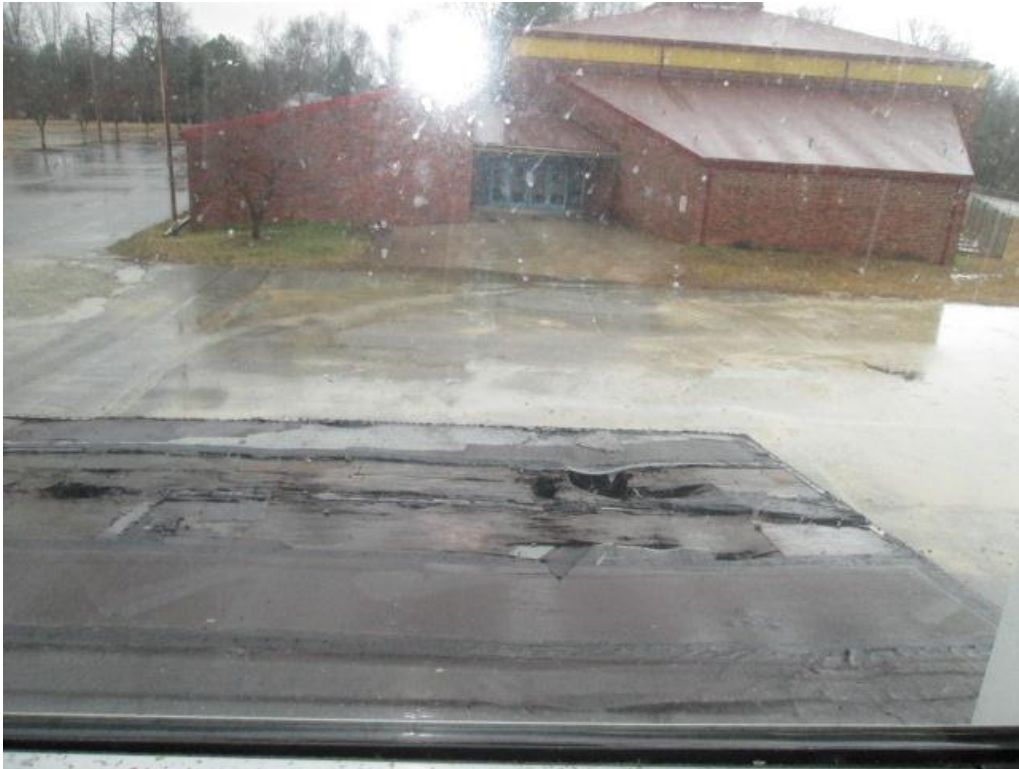
A breach in the roof was observed at the rear storage area (Photo 15). The ceiling at the roof breach has collapsed allowing significant water collection on the floor (Photo 16). A significant rain event occurred during the observation. Approximately ½ inch of water with debris was observed at the floor in the storage area (Photo 17). Based on conversation with staff personnel, consideration has been given to demolishing the rear storage area. The roof and ceiling should be repaired if the storage area is not demolished.

Photo 15: Breach in roof at rear storage area

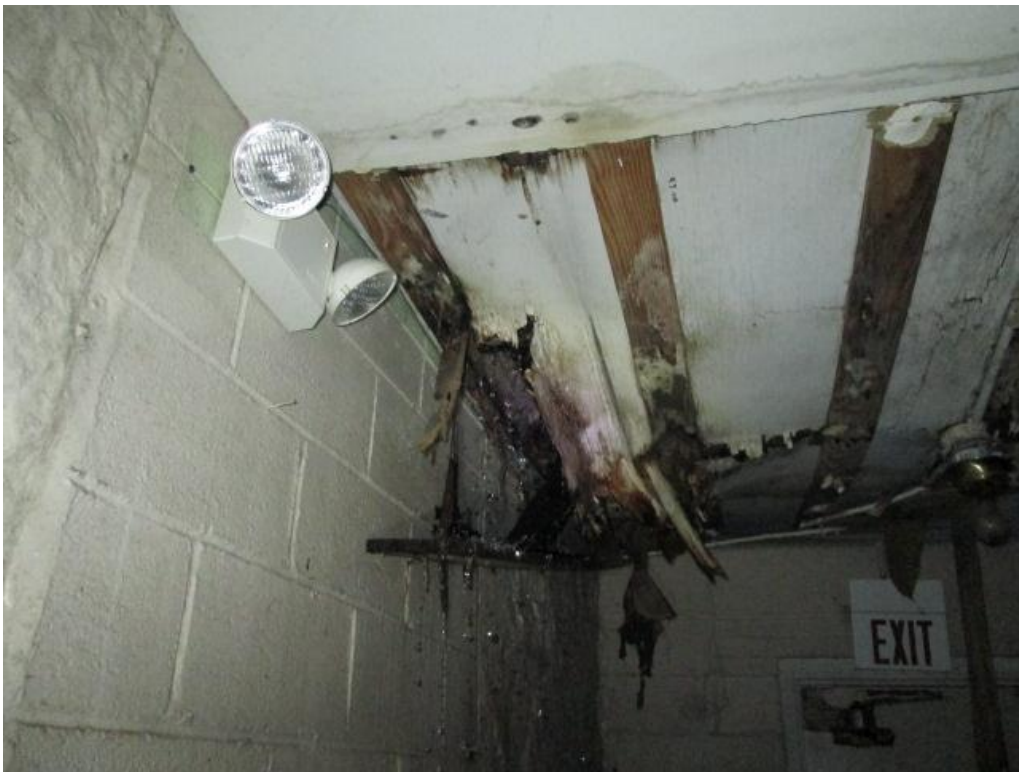
Photo 16: Collapsed ceiling at breached roof of rear storage area

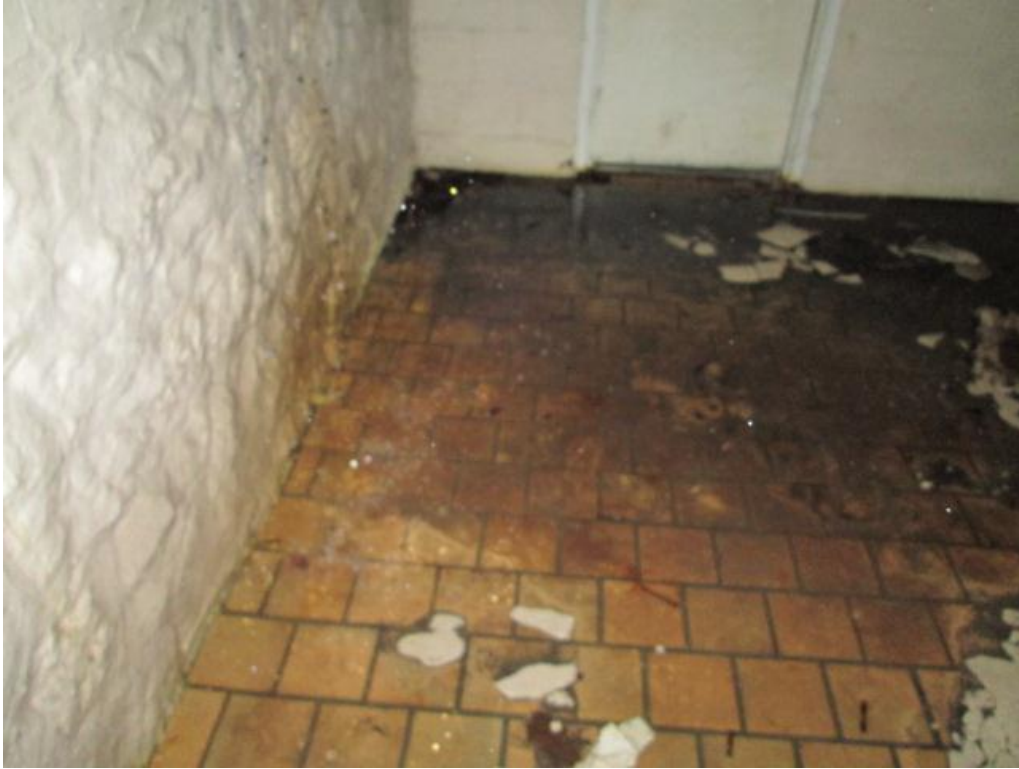
Photo 17: Water and debris on floor at breached roof of rear storage area

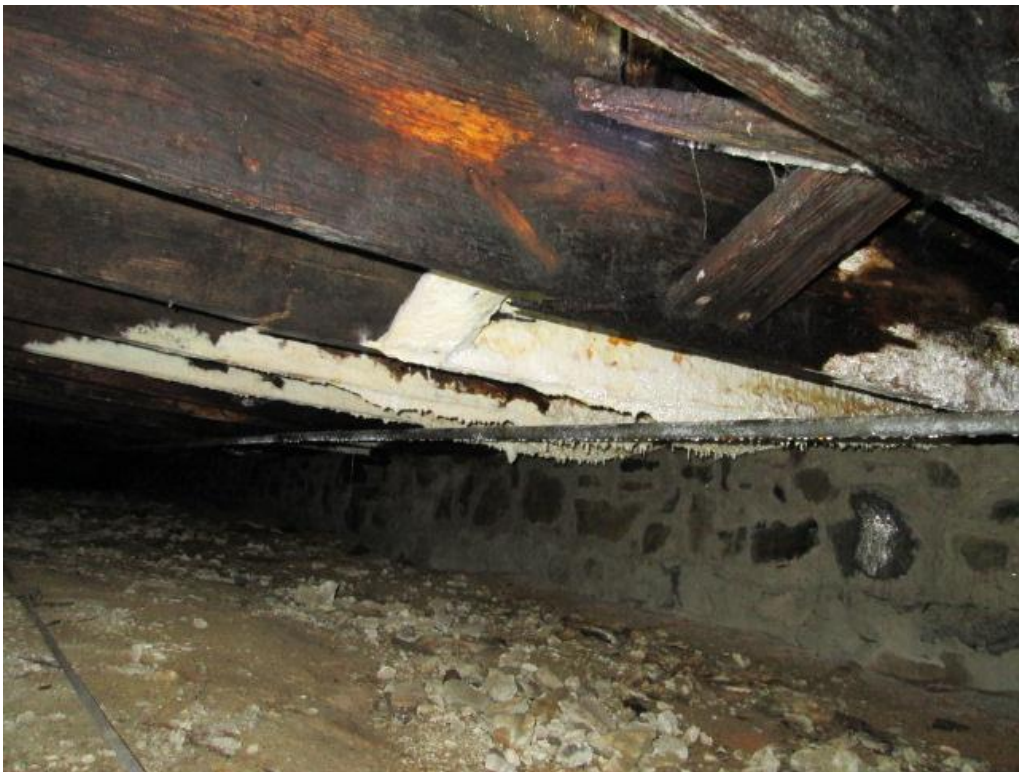
The floor joists consist of full sawn 2x10 members. A white rot or fungus was observed in exterior bays noted on the floor framing plan, in the appendix (Photos 26-28). The deteriorated joists should be replaced.

Photo 26: Decayed floor joist with white mold at north, exterior stone masonry wall

- 1) Replace damaged hardwood flooring above deteriorated floor joists.
- 2) Replace damaged/deteriorated decking.
- 3) Replace all damaged/deteriorated floor joist with pressure treated joists.
- 4) Consider implementing active moisture control measures (i.e. vapor barrier, additional ventilation, waterproof membrane) in the crawl space to limit potential water damage to the floor framing.
- 5) Consider a chemical (borate) treatment for the floor framing.

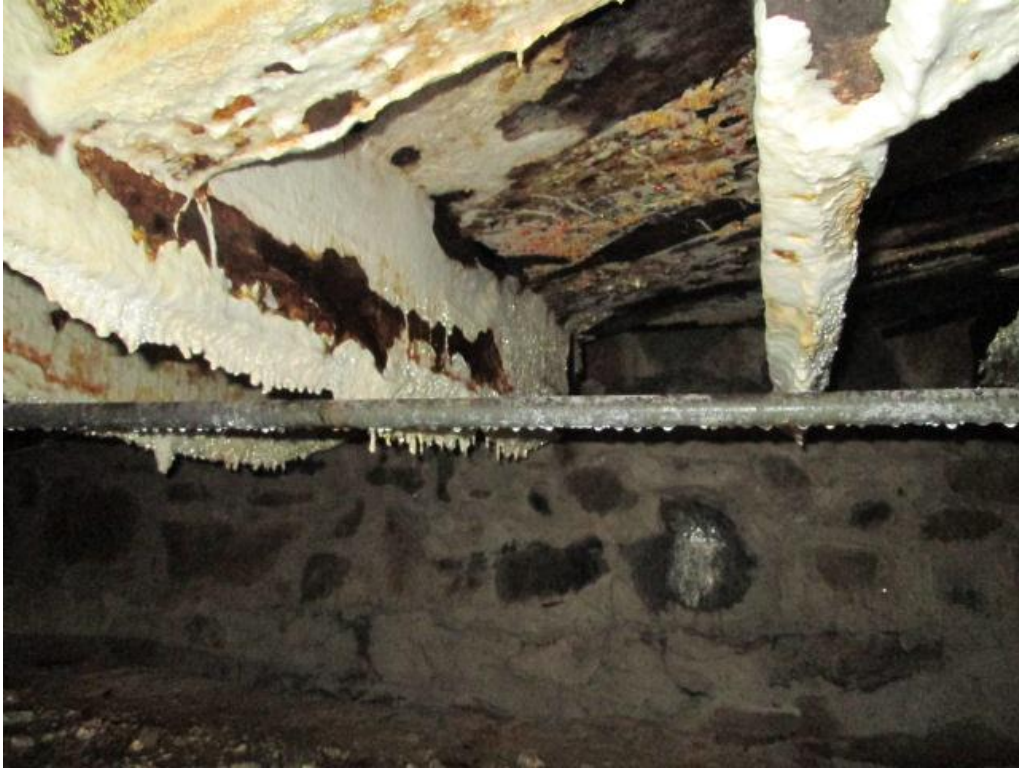
The decking consists of 1x6 tongue and groove diagonal boards (Photo 20). Areas of decking affected by deterioration and/or rot (Photos 27&29) are noted on the floor framing plan in the appendix. The deteriorated decking should be replaced. No significant damage was observed beyond the noted areas of deteriorated floor framing.

Photo 27: Decayed floor joist and decking with white mold at north, exterior stone masonry wall

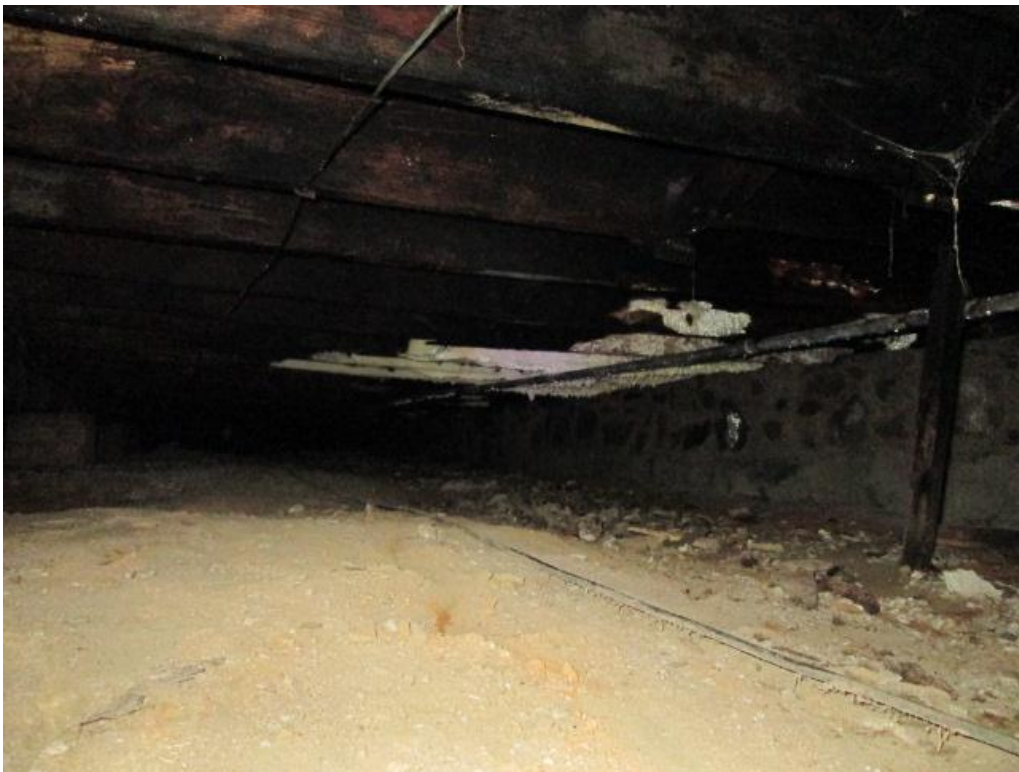
Photo 28: Decayed floor joist with white mold at south, exterior stone masonry wall

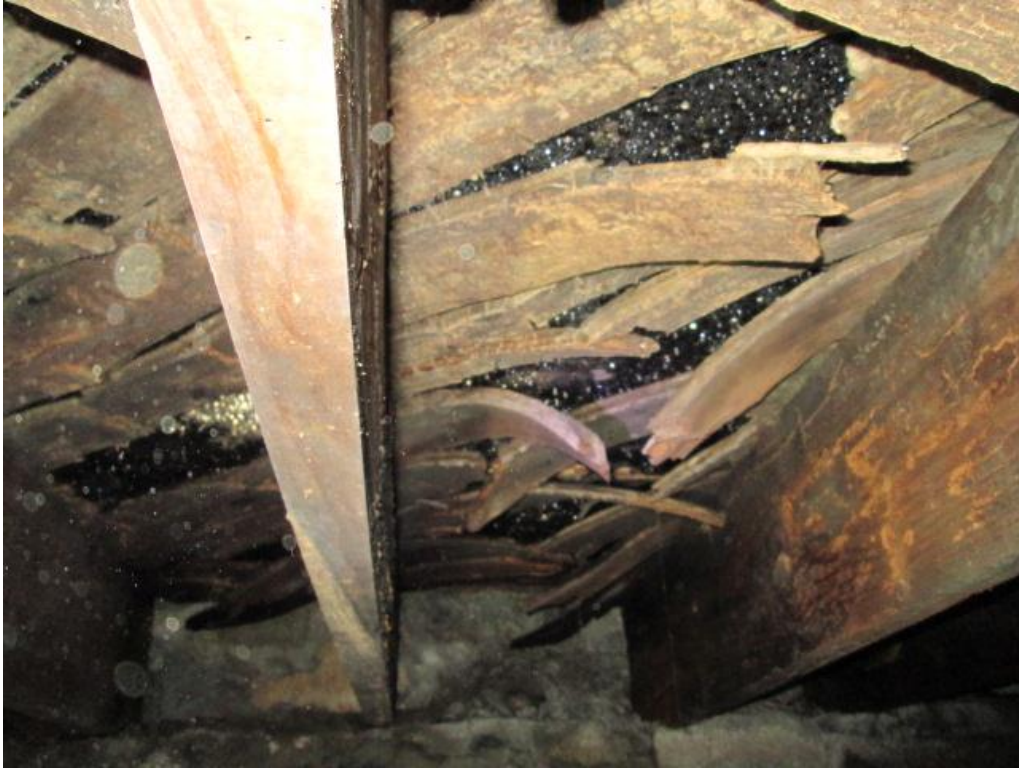
Photo 29: Damaged floor joists at south, exterior stone masonry wall

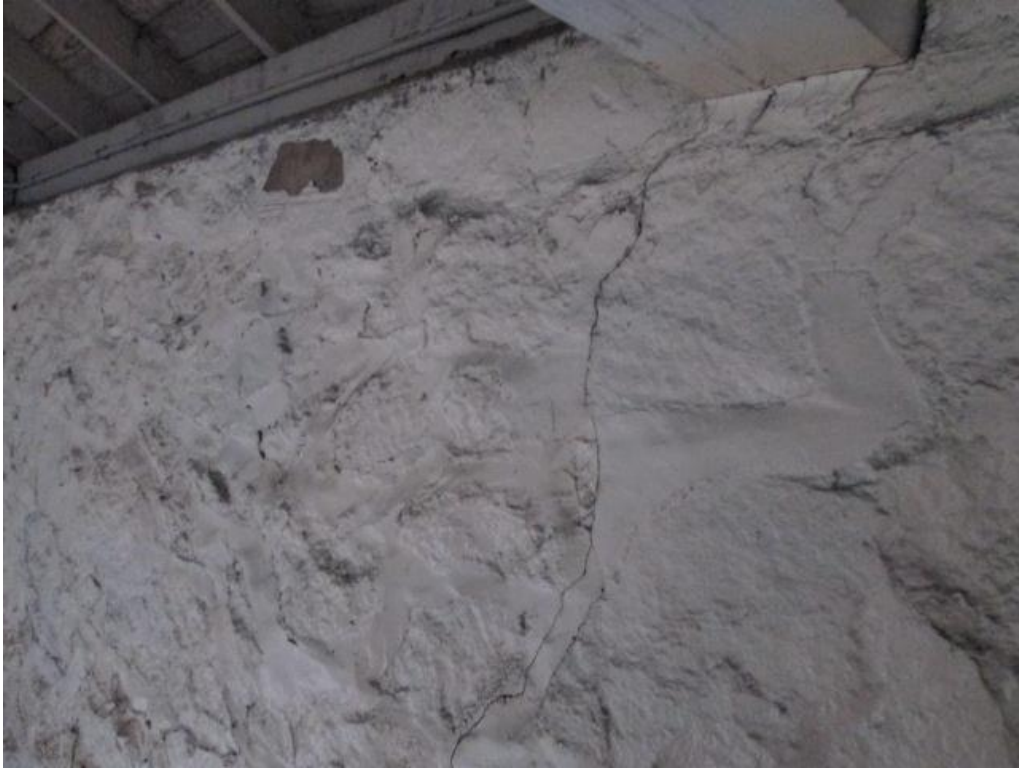
An approximately 1/16 inch wide crack was noted in the south stone masonry wall below Truss 1 (Photo 35). The crack extends down to the top of the window opening (Photo 36). The crack does not present a significant structural hazard at this time but should be monitored for further degradation.

Photo 35: Crack below Truss 1 at south, exterior stone masonry wall

- 1) Monitor crack at the inside face of the south exterior wall below Truss 1 for movement and growth.
- 2) Monitor web section loss at Truss 1 for continued section degradation.
- 3) Monitor section loss at the top chord of Truss 2 for continued section degradation.
- 4) Monitor web section loss at Truss 2 for continued section degradation.
- 5) Monitor bow in bottom chord of Truss 3 for additional warping and deflection.
- 6) Monitor vertical crack in bottom chord of Truss 4 for additional movement.
- 7) Monitor bow in the bottom chord of Truss 4 for additional warping and deflection.
- 8) Provide 2x10 bracing for additional lateral stability at the truss bottom chord.

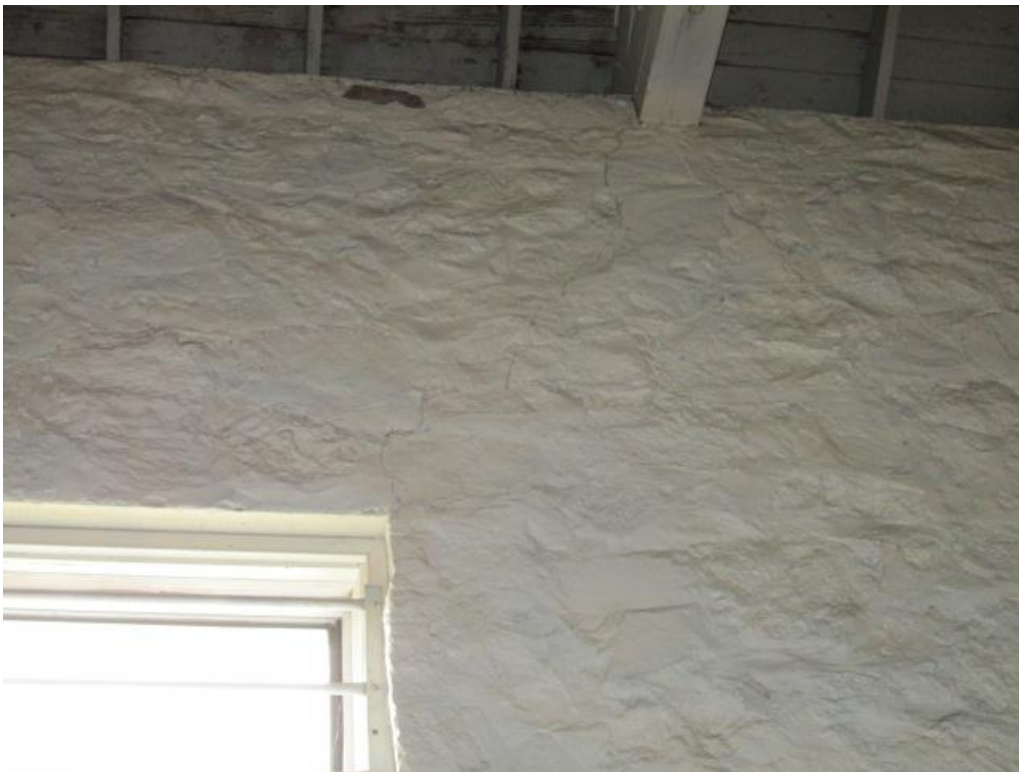
Photo 36: Crack below Truss 1 down to window opening

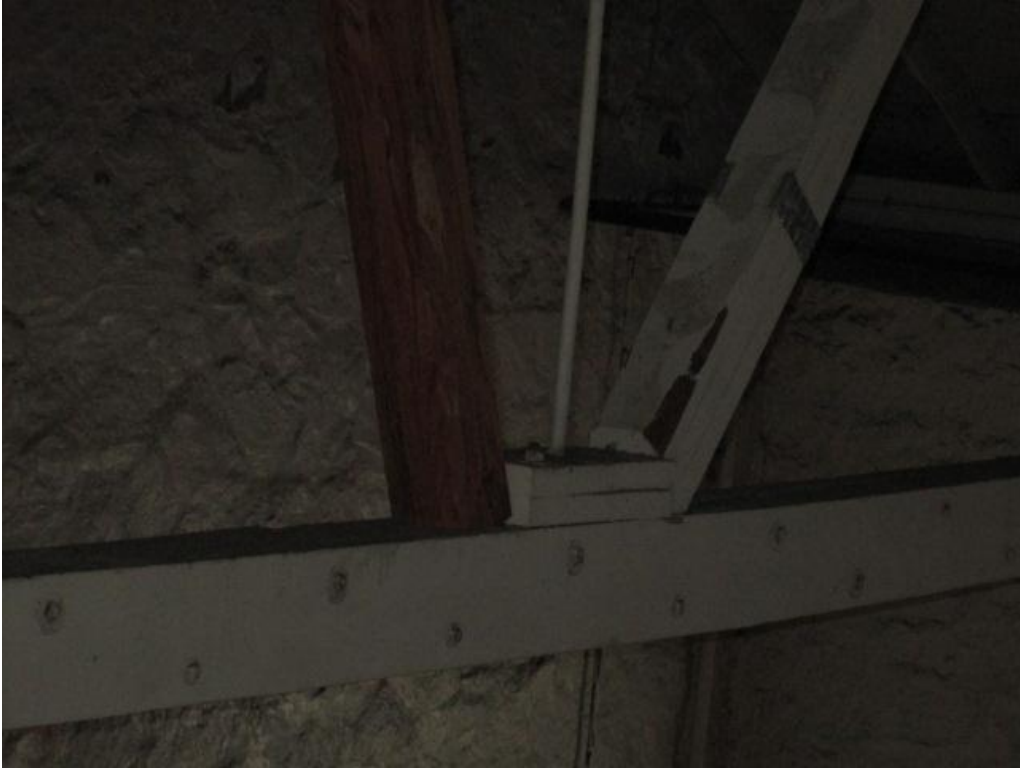
Section loss was observed at the first truss web from the south exterior wall (Photo 37). The section loss does not present a significant structural hazard at this time but should be monitored for further degradation.

Photo 37: Section loss Web at Truss1

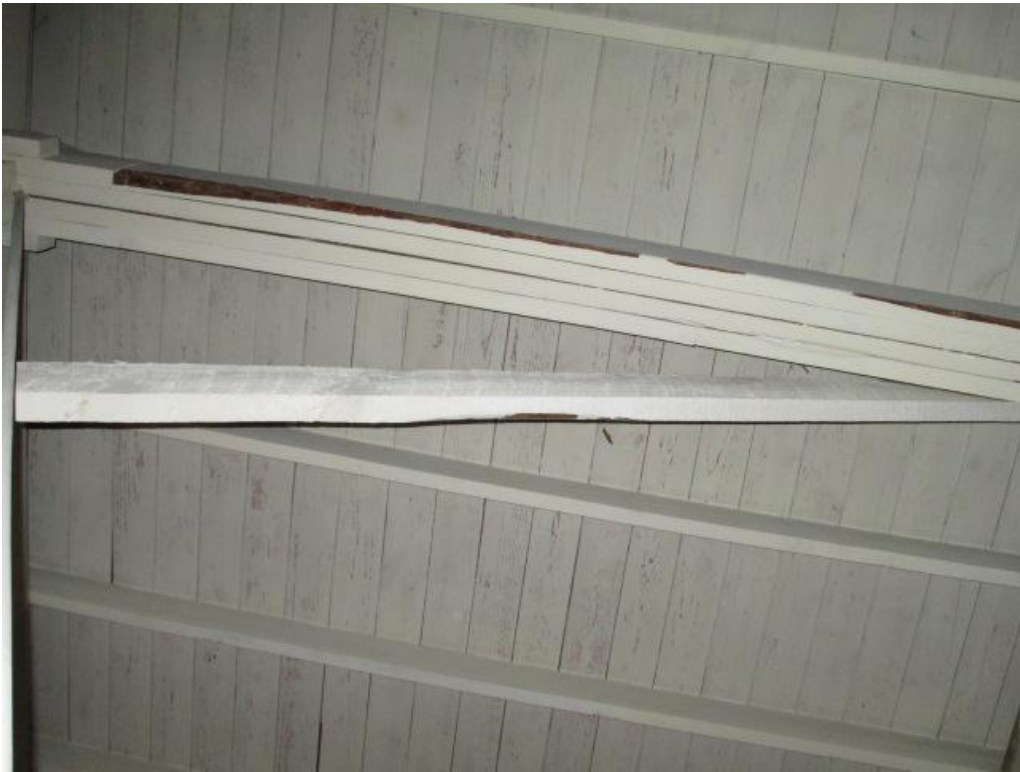
Section loss was observed at the top chord, north of the ridge beam (Photo 38). The section loss does not present a significant structural hazard at this time but should be monitored for further degradation.

Photo 38: Section loss top chord of Truss 2

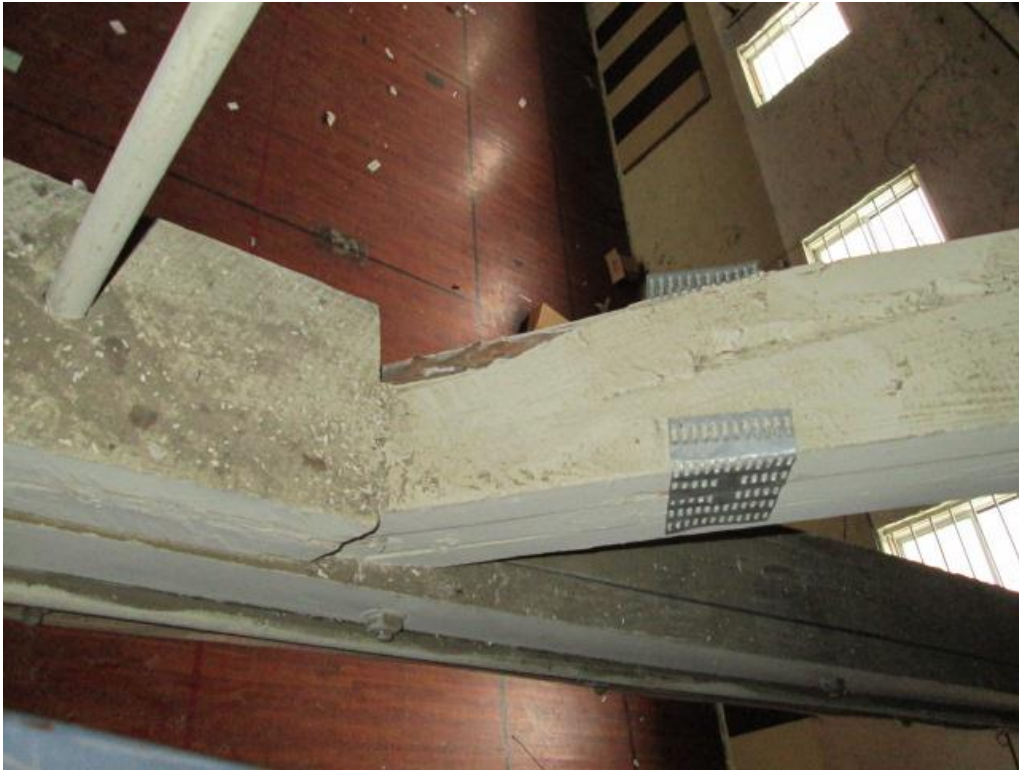
Section loss was observed at the second truss web from the north exterior wall (Photo 39). The section loss does not present a significant structural hazard at this time but should be monitored for further degradation.

Photo 39: Section loss at web at Truss 2

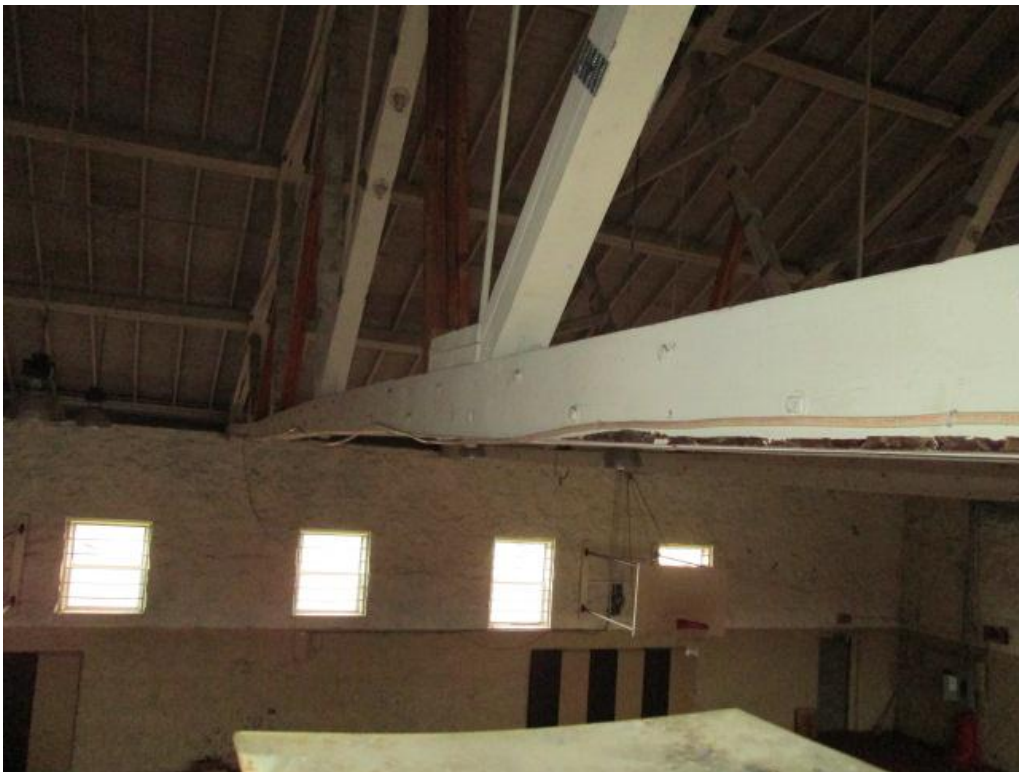
A bow in the truss bottom chord was observed (Photo 40). It was unclear whether the bow is a function of structural loading or initial straightness of the lumber. The bow should be monitored for further movement.

Photo 40: Warped bottom chord at Truss 3

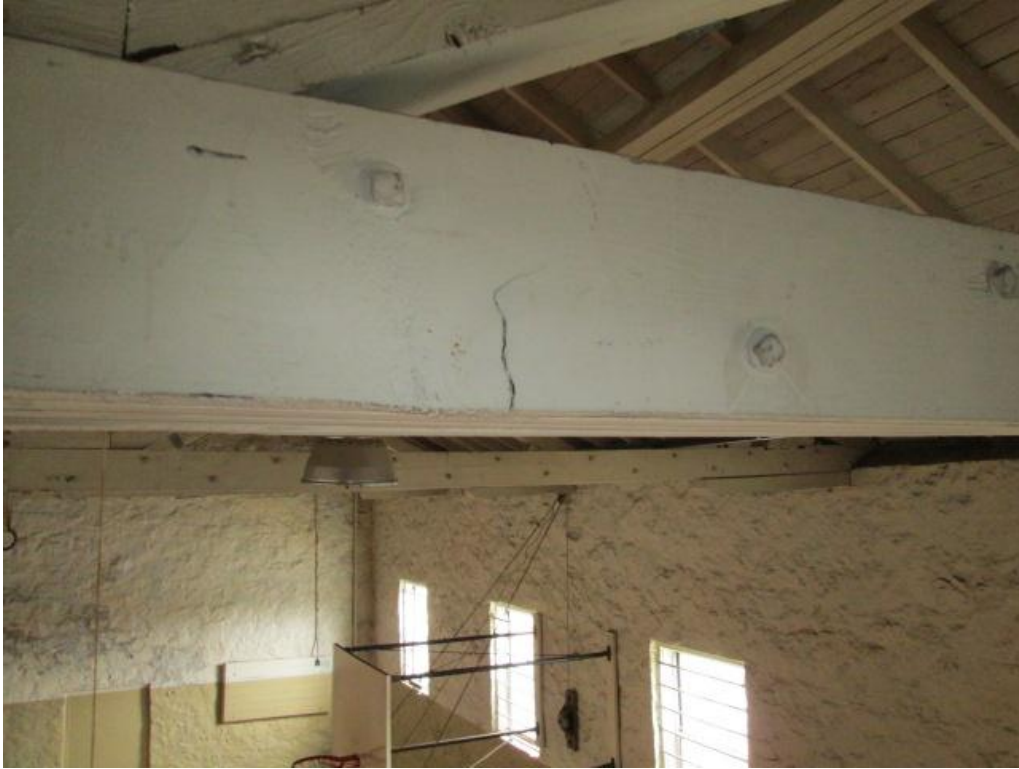
A 1/8 inch (wide) x 3-1/2 inch long vertical crack was observed in the bottom chord below the first web from the south wall (Photo 41). The crack does not present a significant structural hazard at this time but should be monitored for further degradation.

Photo 41: Crack at bottom chord of Truss 4

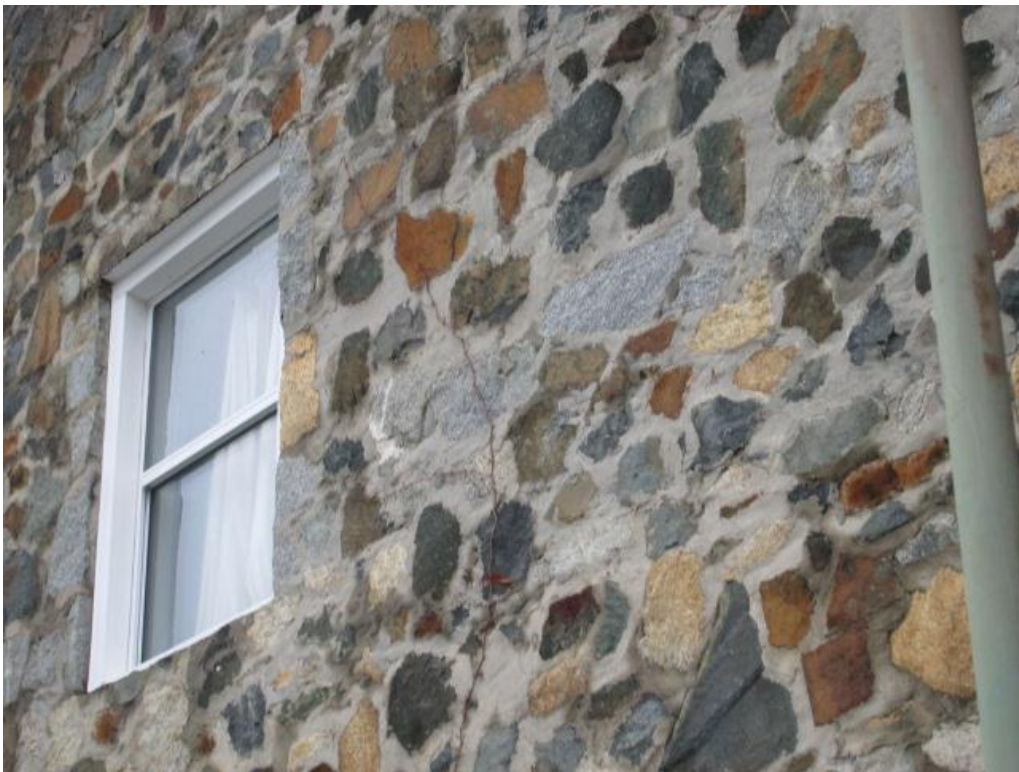
The stone masonry walls appeared to be in good condition. No significant cracks, spalls or deterioration was observed on the exterior face of the stone masonry walls. Some vegetation growth was observed on the west elevation (Photo 42). The vegetation may present a risk to the integrity of the walls and should be removed.

Photo 42: Vegetation growth on west elevation stone masonry walls
